Contract #: 04-0120F4Cty: SF/ALA Rte: 80 PM: 13.2/13.9File #: 69.28**WELDING INSPECTION REPORT****Resident Engineer:**Siegenthaler, Peter**Address:** 333 Burma Road**City:** Oakland, CA 94607**Report No:** WIR-018618**Date Inspected:** 13-Dec-2010**Project Name:** SAS Superstructure**OSM Arrival Time:** 645**Prime Contractor:** American Bridge/Fluor Enterprises, a JV**OSM Departure Time:** 1845**Contractor:** Zhenhua Port Machinery Company, Ltd (ZPMC), Changxing Island **Location:** Shanghai, China**CWI Name:** Liu Hua Jie.**CWI Present:** Yes No**Inspected CWI report:** Yes No N/A**Rod Oven in Use:** Yes No N/A**Electrode to specification:** Yes No N/A**Weld Procedures Followed:** Yes No N/A**Qualified Welders:** Yes No N/A**Verified Joint Fit-up:** Yes No N/A**Approved Drawings:** Yes No N/A**Approved WPS:** Yes No N/A**Delayed / Cancelled:** Yes No N/A**Bridge No:** 34-0006**Component:** Orthotropic Box Girder(OBG)**Summary of Items Observed:**

WELDING INSPECTION REPORT

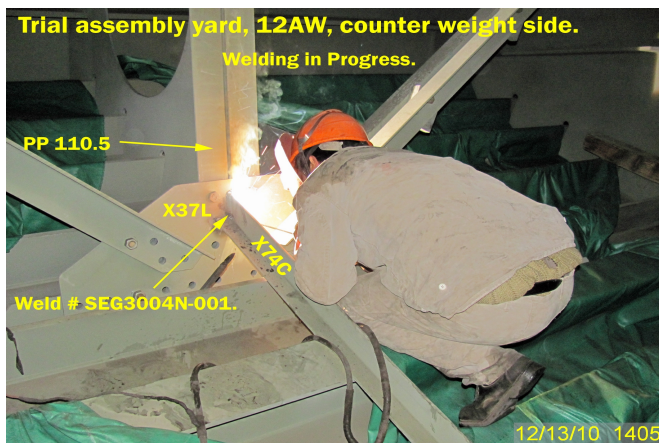
Trial assembly yard, 12AW, X74C, X74D to X37L.

SMAW welding of weld joint SEG3004N-001, 002; located at Trial assembly yard. Welder is identified as 045268; ZPMC Quality Control Inspector (QC) is identified as Zhang Qiang. The welding variables recorded by Quality Control Inspector (QC) appeared to comply with the Applicable WPS: WPS-B-P-2112, WPS-B-P-2113, WPS-B-P-2114. The attached photographs provide additional detail
